# Gregory L. Bone, PE

February 5, 2021

Re: Structural Inspection  
2944 E. Pebblestone Drive  
Fayetteville, Arkansas 72701

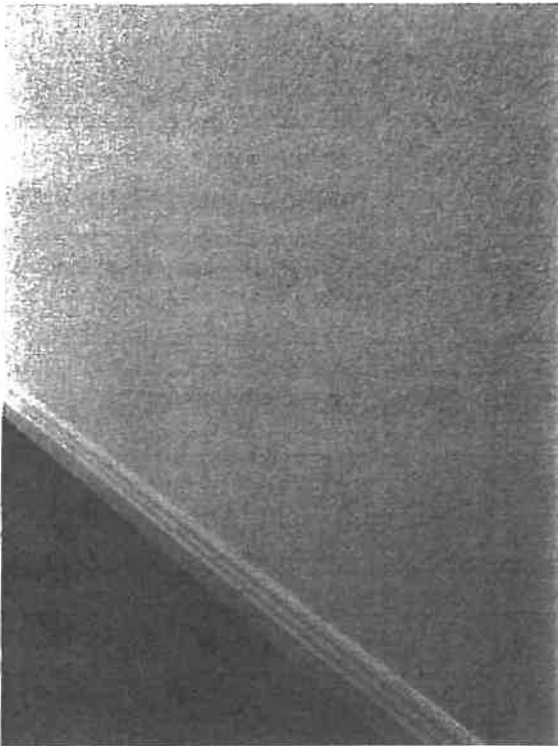
**Hairline vertical drywall crack at panel seam.**

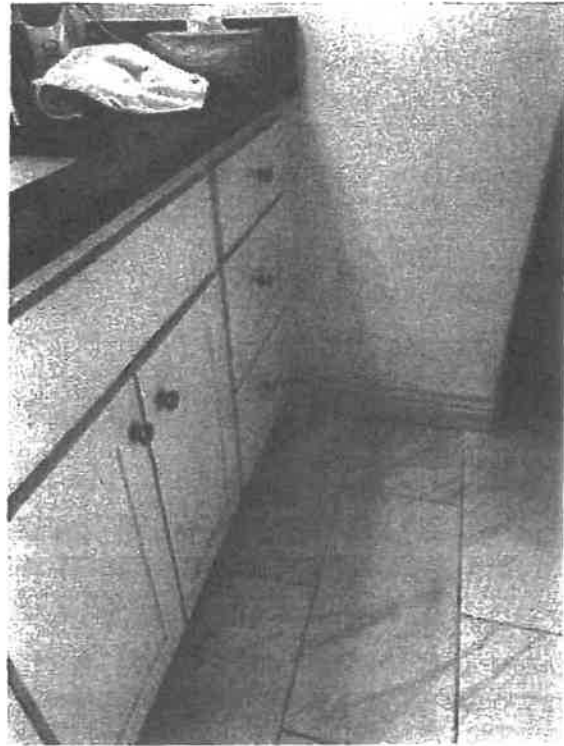
**Slightly irregular tiled floor surface in bath.**

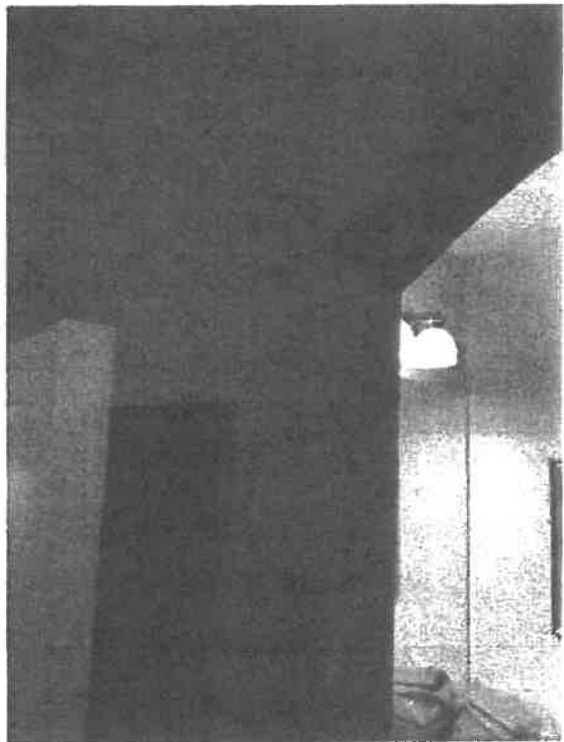
**Hairline crack at arched corner bead.**
